# **PRIOR REPORTS**

THIS DISCLOSURE STATEMENT CONCERNS THE REAL PROPERTY SITUATED IN THE CITY OF Oakland, COUNTY OF Alameda, STATE OF CALIFORNIA, DESCRIBED AS 1096 Amity

THIS WOOD DESTROYING PEST AND ORGANISM REPORT IS IN COMPLIANCE WITH THE STRUCTURAL PEST CONTROL ACT REPORT REQUIREMENTS (TITLE 16, CHAPTER 19, SEC. 1990, 1191 AND 1992). THIS INSPECTION AND REPORT IS LIMITED TO THE ABSENCE AND PRESENCE OF WOOD DESTROYING PESTS AND ORGANISMS OR CONDITIONS CONDUCIVE TO, AND TO MAKE RECOMMENDATIONS FOR CORRECTIONS WITH AN ITEMIZED PRICE QUOTE FOR REPAIRS ATTACHED.

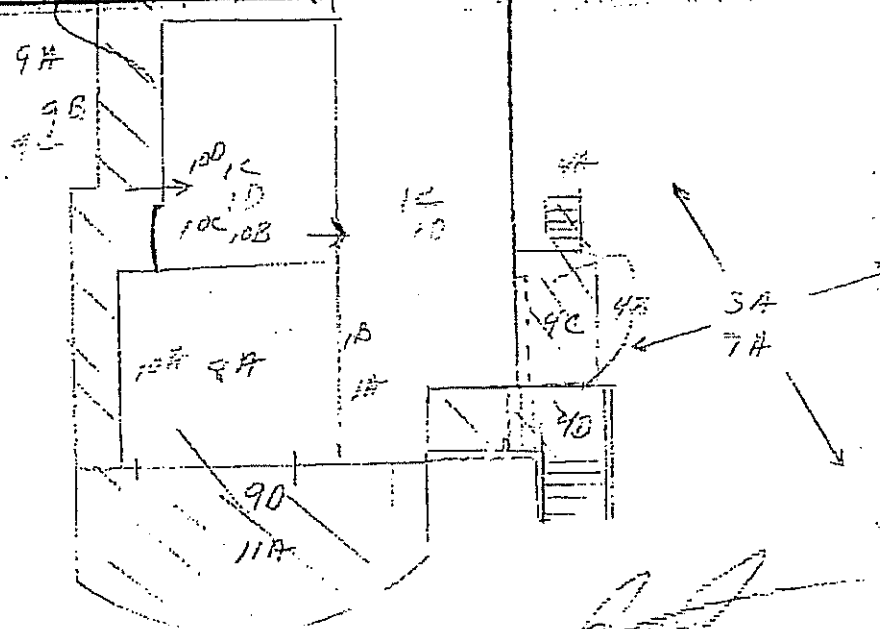
DIAGRAM AND EXPLANATION OF FINDINGS ( This report is limited to structure or structures shown on diagram)

1A FINDING: I noted a fungus infected form board to be left in place in the substructure as indicated by 1a on the diagram.

1B FINDING: I noted earth to wood contacts to the partition wall framing as indicated by 1b on the diagram.

4A FINDING: The base of the stairs as indicated by 4a on the diagram was noted to be in earth contact with decay present.

4C FINDING: I noted fungus growth below the side deck system as indicated by 4c on the diagram.

9C FINDING: I noted moss and deterioration growing at the lower deck system as indicated by 9c on the diagram.

RECOMMENDATION: Remove as much of this form board as practical and treat the remainder with Tim-bor

RECOMMENDATION: Grade soil at this area to eliminate earth to wood contact conditions.

RECOMMENDATION: Cut off the base of the steps and install an elevated concrete bottom step at this area to eliminate this condition.

RECOMMENDATION: Wire brush infected area and chemically treat with Tim-bor. Upon completion of this repair parties of interest should keep this area sealed and maintained at all times to help prevent future intrusion and decay from occurring.

RECOMMENDATION: Owner should have this area cleaned and sealed to help prevent future intrusion and decay from occurring.
