PROPERTY TAX DISCLOSURE REPORT FOR:

Property Address: 2943 RUSSELL ST

FINDINGS AND RECOMMENDATIONS**Exterior**

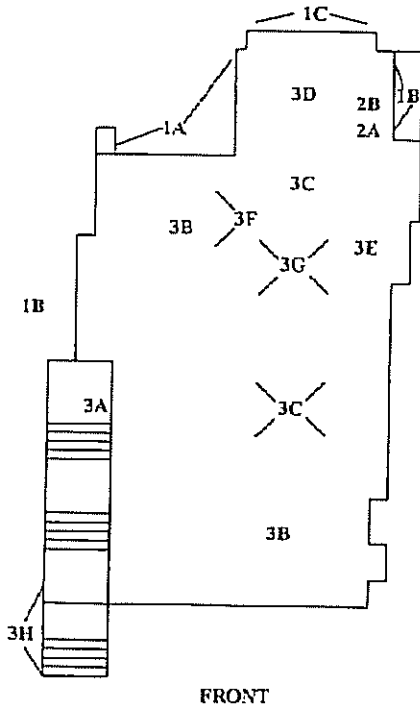
Note: Diagram Not to Scale

1A FINDING: At the area indicated on the diagram, the mudsill (the piece of wood that sits on top of the foundation) is below the level of the ground, creating a faulty grade level. This condition exposes the wooden elements of the structure to the moisture in the ground and provides concealed access into the structure for any termites which might be in the ground. However, the owner's contractor has recently installed a strip drain across the rear portion of the building and there was no evidence of any wood-destroying pests in the visible and accessible areas or of any moisture penetration in this area. (SECTION II)

3A FINDING: The base of the 2x4 studs underneath the concrete front entryway have been damaged by fungus infection at the area indicated on the diagram. This damage has been caused by water penetrating through the surface of the concrete above. (SECTION I)

basement have been damaged by fungus infection at the area indicated on the diagram. (SECTION I)

3F FINDING: At the area indicated on the diagram there is earth-wood contact, which exposes the mudsill to the moisture in this soil and provides hidden access for subterranean termites. There does not appear to be any damage to the wood. (SECTION II)

3H FINDING: As visible from the subarea, there was fungus damage to the sheathing, framing, and mudsill at the left side of the stucco abutment adjacent to the stairs that lead to the front entryway. The only way of knowing exactly how far the damage behind the stucco extends in all directions is to uncover the damage by removing the stucco. Such removal is not practical and is not a part of our standard pest control inspection. Our recommendation is based on our assumption about the extent of the damage. We may discover more damage in the course of our repairs. (SECTION I)

RECOMMENDATION: Remove and replace the damaged wood members as necessary. NOTE: After the repairs have been completed, the Owner should keep the concrete stairs and landing well-sealed at all times to prevent moisture penetration in the future.
COST: \$500

RECOMMENDATION: Cut off the damaged sections of the 2x4 framing members and install raised concrete piers to support the framing members in this area.
COST: \$1400

RECOMMENDATION: Grade back the soil as necessary to break this earth-wood contact.
COST: \$150

RECOMMENDATION: Our recommendation is to remove the stucco from the outside of the abutment, starting at the left-front of the entryway stairs and leading towards the rear of the building approximately twelve feet, and from the base of the wall to the top of the stucco abutment, and to remove and replace the structurally-damaged sheathing and framing found in this area. In addition, provide and install stucco paper, stucco wire, and new stucco with a texture to match the existing stucco as closely as reasonable. Prime paint the new stucco. If in the course of performing these repairs damage is found to extend beyond the limits specified above, we will issue a Supplemental Report with findings and recommendations for additional repairs at additional costs. We will proceed with the additional repairs only with the owner's written authorization.
COST: \$6500
