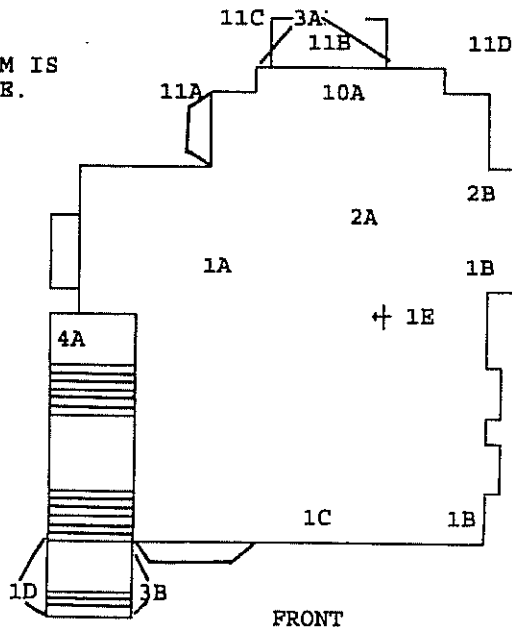
DIAGRAM AND EXPLANATION OF FINDINGS (This report is limited to structure or structures shown on diagram)

- 1A. FINDING: Others have installed plywood panels with inspection holes cut into the plywood on the lower base framing at various locations in the subarea. Inspection of the areas behind the plywood with a flashlight revealed no indications of infestation, infection or damage from wood destroying pests or organisms. (SECTION II)

- RECOMMENDATION: The Owners should have this and other parts of the building inspected regularly as part of a home maintenance program.
- COST: OWNER
- 1B. FINDING: Subterranean termite tubes were found scattered throughout the lower base framing along the right side of the subarea. The tubes were broken open and they were dry and appeared to be abandoned. There were no signs of active infestation. (SECTION I)

- COST: \$50
- 1C. FINDING: There were water stains on the subfloor and wall sheathing at the right-front corner of the building. This is an indication that water has penetrated through the exterior stucco surface of the building. However, there was no evidence of wood-destroying pests or organisms at the time of this inspection. (SECTION II)

1D. FINDING: A test hole in the stucco abutment at the left side of the entry stairs revealed **fungus damage** to the sheathing and framing. The only way of knowing exactly how far the damage behind the stucco extends in all directions is to uncover the damage by removing the stucco. Such removal is not practical and is not a part of our standard pest control inspection. Our recommendation is based on our assumption about the extent of the damage, but we may discover more damage in the course of our repairs. (SECTION I)

1E. FINDING: Three 2X4 studs in the partition wall at the right side of the stairs that lead down to the basement are in contact with the earth. The 2X4 studs have been **damaged by fungus infection** at the base. (SECTION I)

2A. FINDING: The upstairs stall shower was not tested at the time of this inspection. The Owner informed us that the **shower has been leaking** onto the ceiling in the room directly below this stall shower and the sheetrock of the ceiling has recently been repaired. (SECTION II)

2B. FINDING: We water tested the stall shower in the downstairs hall bathroom for at least fifteen minutes after we plugged the shower drain and filled the base to within one inch of the top of the shower dam (the curb that you step over in order to enter the shower). Leakage was evident below the shower with **fungus damage** to the sheathing and framing members. (SECTION I)

There is a **faulty grade condition** at the rear of the building where the concrete patio has been poured up against the rear of the building. This condition exposes the wooden members of the structure to the moisture in the ground which provides easy, hidden access for any termites which might be in the soil. However, there was no evidence of any wood destroying pests or organisms in the visible and accessible areas at the time of the inspection. (SECTION II)

- RECOMMENDATION: Remove or mask over all accessible termite tubes. In light of the evidence of previous infestation, the Owner should have this area inspected regularly.

RECOMMENDATION: Our recommendation is to remove the stucco a maximum of 16' starting at the left-front corner of the banister and leading towards the rear of the building and from the ground upwards approximately 6'. Remove and replace the structurally damaged wood members and sheathing. In addition, provide and install stucco paper, stucco wire, and new stucco with a texture to match the existing stucco as closely as possible. Prime paint the new stucco.

RECOMMENDATION: Cut off the bottom of the 2X4's and install on a pre-cast concrete pier.

RECOMMENDATION: The Owner should contact a licensed contractor who specializes in bathroom stall showers for the removal and replacement of this shower.

RECOMMENDATION: The Owners should contact a licensed contractor who specializes in bathroom remodeling for the removal of the existing shower, the removal and replacement

Install a concrete flashwall bonded to the foundation and extending above the exterior earth level to isolate the wooden members from the soil.
