# **PRIOR REPORTS**

THIS DISCLOSURE STATEMENT CONCERNS THE REAL PROPERTY SITUATED IN THE CITY OF Oakland, COUNTY OF Alameda, STATE OF CALIFORNIA, DESCRIBED AS 1096 Amity

THIS WOOD DESTROYING PEST AND ORGANISM REPORT IS IN COMPLIANCE WITH THE STRUCTURAL PEST CONTROL ACT REPORT REQUIREMENTS (TITLE 16, CHAPTER 19, SEC. 1990, 1191 AND 1992). THIS INSPECTION AND REPORT IS LIMITED TO THE ABSENCE AND PRESENCE OF WOOD DESTROYING PESTS AND ORGANISMS OR CONDITIONS CONDUCIVE TO, AND TO MAKE RECOMMENDATIONS FOR CORRECTIONS WITH AN ITEMIZED PRICE QUOTE FOR REPAIRS ATTACHED.

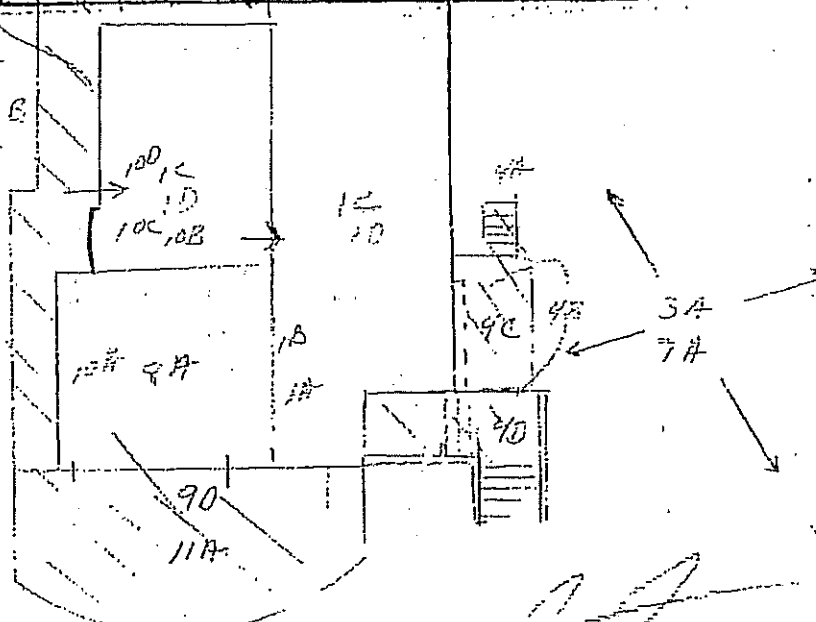
DIAGRAM AND EXPLANATION OF FINDINGS (This report is limited to structure or structures shown on diagram)

1. SUBSTRUCTURE AREA	REFER TO 1				
2. STALL SHOWER	REFER TO 2				
3. FOUNDATIONS	REFER TO 3				
4. PORCHES - STEPS	REFER TO 4				
5. VENTILATION	APPEARS ADEQUATE

6. ABUTMENTS	STUCCO				
7. ATTIC SPACES	REFER TO 5				
8. GARAGES	REFER TO 8				
9. DECKS - PATIOS	REFER TO 9				
10. OTHER - INTERIOR	REFER TO 10				
11. OTHER - EXTERIOR	REFER TO 11
