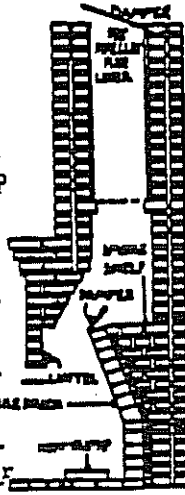
FIREPLACE :- The firebox is in poor condition with deteriorated + eroded mortar + loose bricks. The smoke chamber is in good condition - there is no damper. The facing + hearth are in good condition and of conforming size.

Satisfactory	Unsatisfactory	Not Applicable
Brickwork	✓	SEE	
Mortar	✓	NOTES	
Flue tiles	✓		
Crown Wash	✓		
Spark/raincap	✓		
Hearth	✓		
Firebox	✓	✓	
Facing	✓		
Damper	NO DAMPER		
Smoke chamber	✓

RECOMMEND :-
