6101 CONTRA COSTA ROAD, OAKLAND, CALIFORNIA

BUILDING INSPECTION REPORT

INSPECTION DATE:
JANUARY 4, 2002

PREPARED BY:
MARTIN REUTINGER
RESIDENTIAL DESIGN & CONSULTING
California General Contractor #406439
1818 Harmon Street
Berkeley CA 94703
(510) 658-2626 (PHONE)
(510) 658-2778 (FAX)
e-mail: mreut@lmi.net

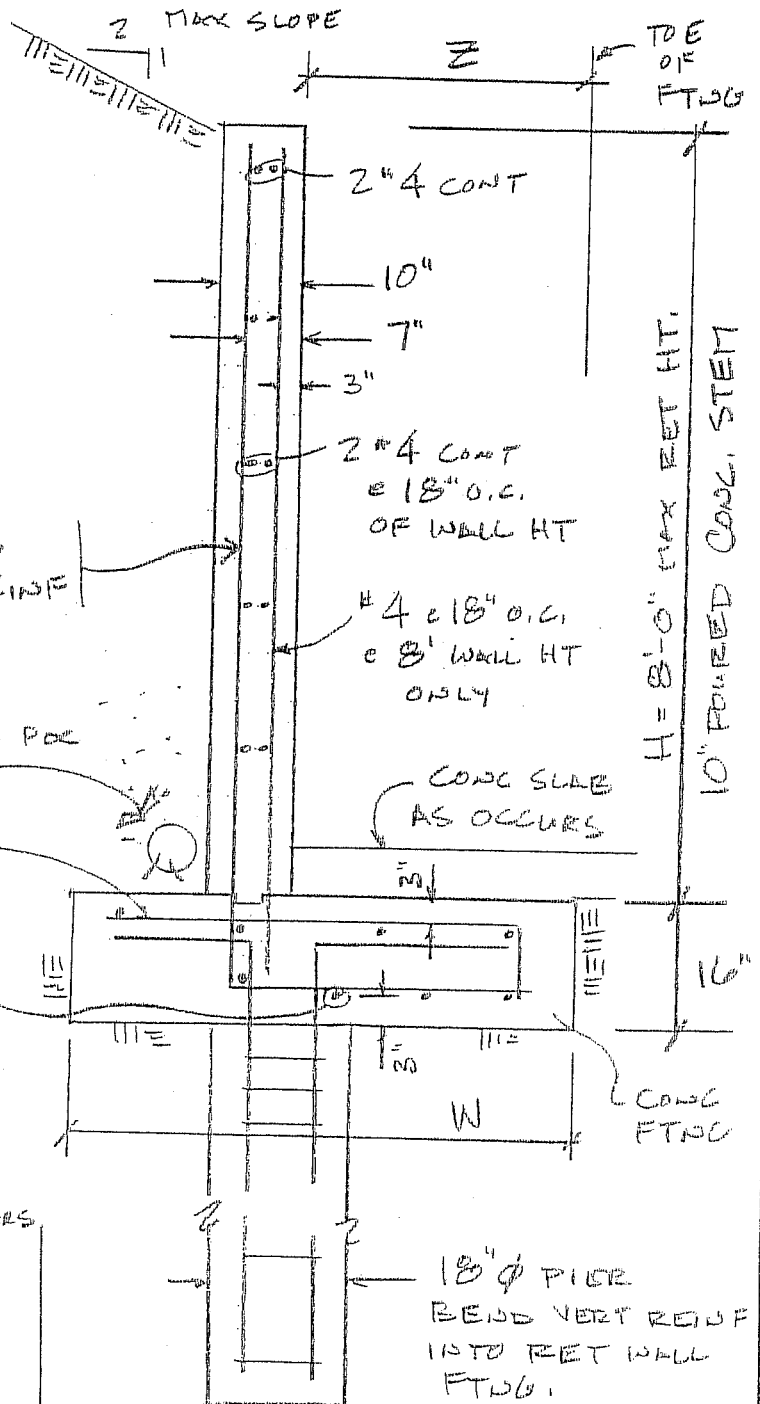
RETAINING WALL DETAIL

$\frac{1}{2}'' = 1'-0''$
 $f_c = 2500$ psi MIN CONC
 GRADE 60 REINF
 40 BAR ϕ MID LAP
 WATERPROOF & DRAIN BACK
 OF WALL PER SOIL ENG.
 WATERPROOF ALONG COLD
 JOINTS TO ENSURE NO WATER
 SEEPAGE THRU WALL OR FTNG.

"A" BARS VERT REINF

PERF PIPE & DRAIN ROCK FOR SOIL ENG.

H	W	Z	"A" BARS	"B" BARS
4'-0"	2'-10"	1'-4"	#4 @ 18"	4 " 5
5'-0"	3'-5"	1'-9"	#5 @ 18"	5 " 5
6'-0"	4'-0"	2'-2"	#5 @ 18"	5 " 5
7'-0"	4'-8"	2'-7"	#5 @ 12"	6 " 5
8'-0"	5'-4"	3'-0"	#5 @ 12"	6 " 5

RETAINING WALL DESIGN
